*Cascade Inspection Services, LLC*  
Property Inspection Report

1234 Memory Lane, Corvallis, OR 97330  
Inspection prepared for: John Smith & Sarah Smith  
Date of Inspection: 6/8/2015 Time: 8:30 A.M.  
Age of Home: 14 years old Size: 2352 Sq Ft  
Weather: Sunny

Inspector: Benjamin Zedwick  
OCHI #1971 CCB# 214140

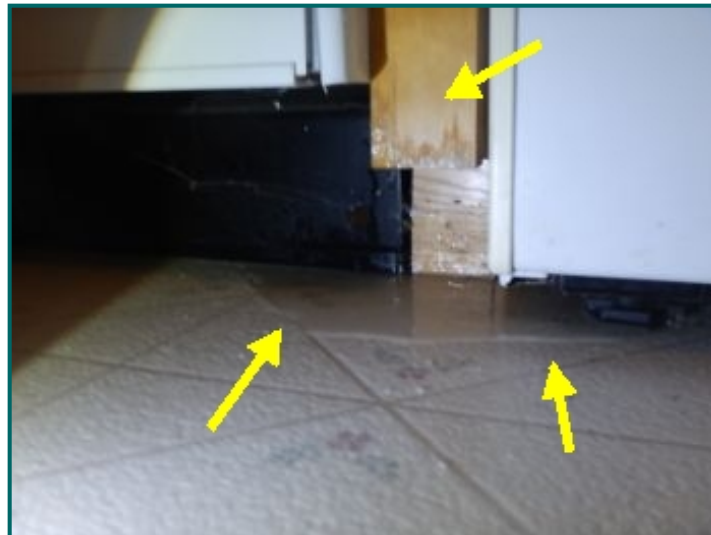
- **Dishwasher leaked during testing. Recommend either replacing the unit or having it repaired by a qualified technician. Continued use of the machine while it is leaking could cause extensive damage to the home.**

Dishwasher leaked.

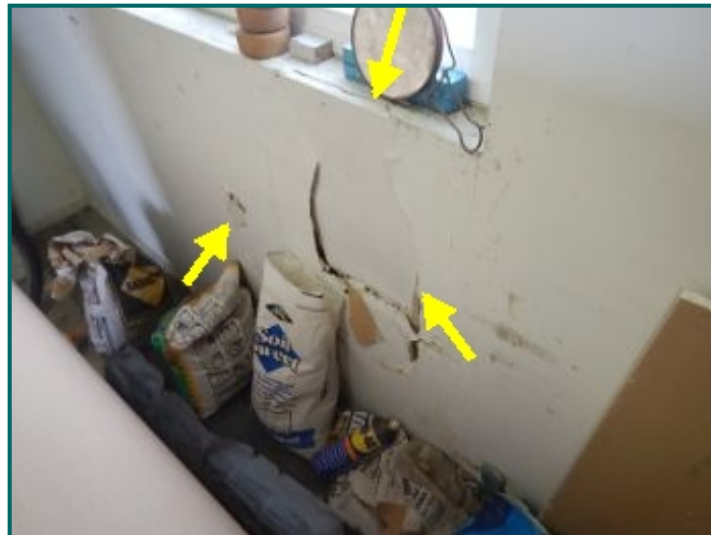
- Drywall damage noted in garage. Recommend repair/replacement.

Dry wall damage noted.

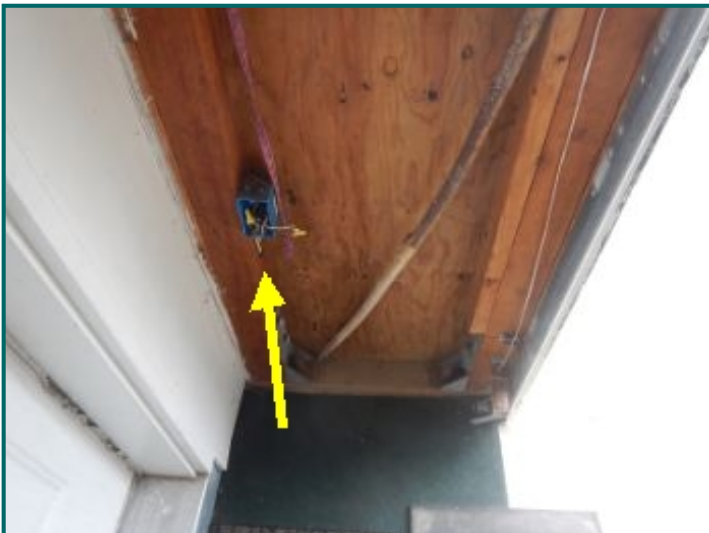
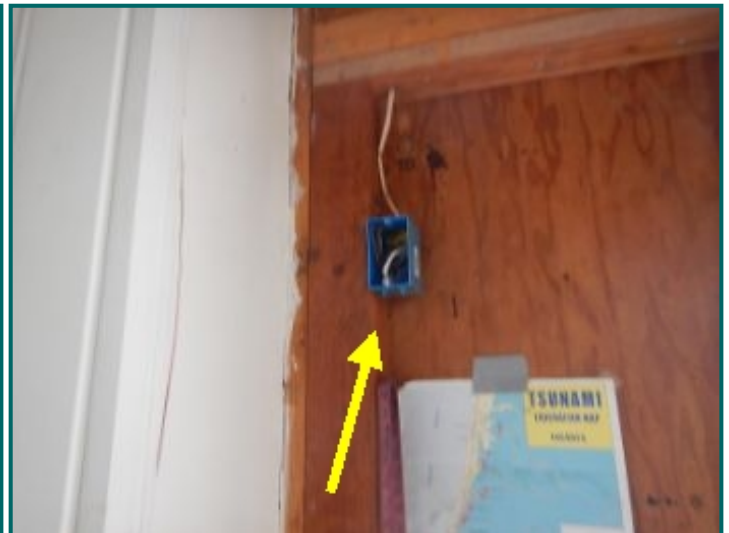
- Some outlets not accessible due to furniture and/or stored personal items.
- Electrical junction box plates missing. This can be an electrical hazard.

Electrical cover missing

Electrical cover missing.

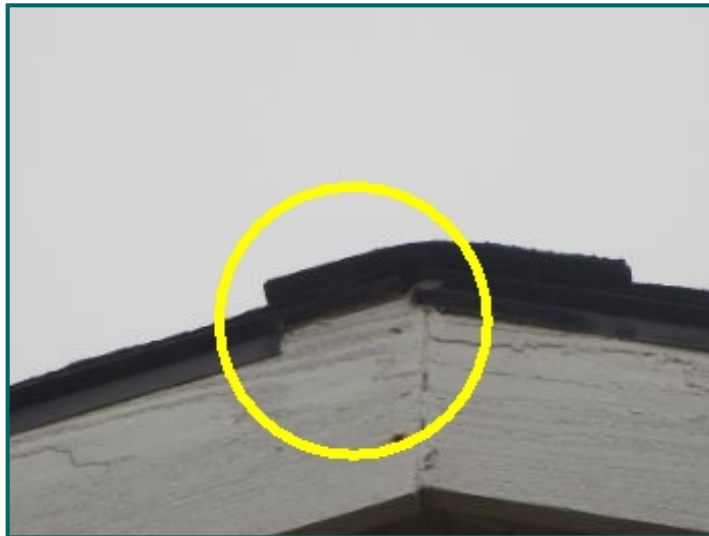
- Insufficient roof flashing. It appears there are incomplete drip-edges installed.

Incomplete drip-edge flashing

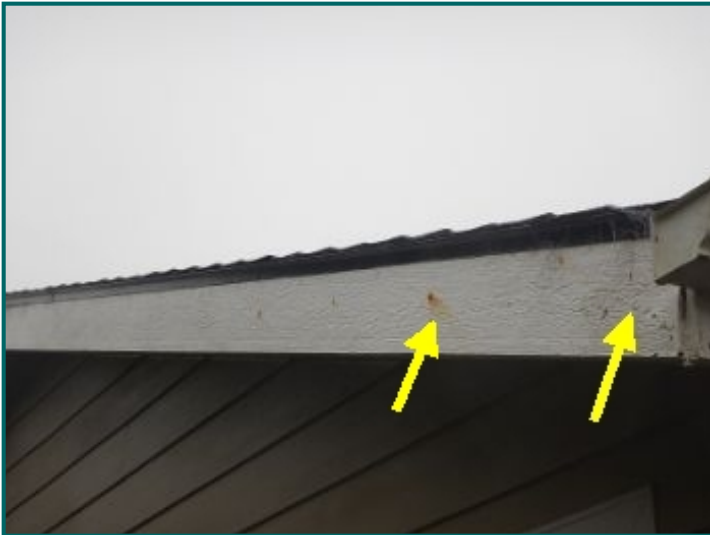
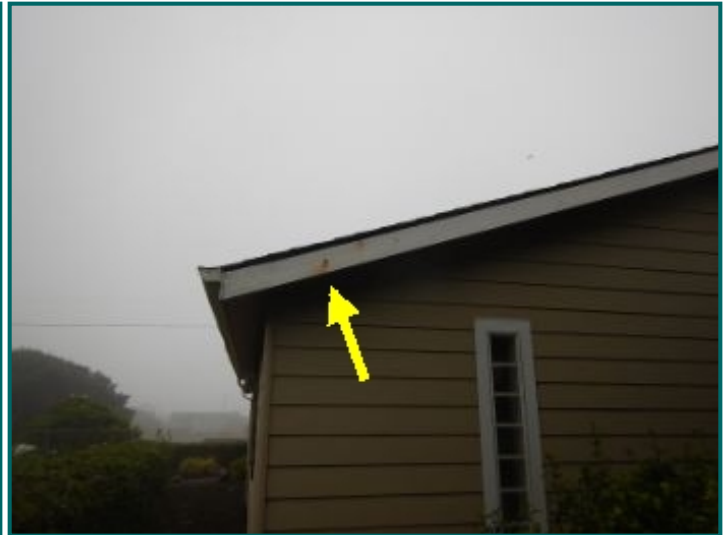
- **Moisture damage and wood rot observed on fascia. Recommend having a licensed contractor evaluate and repair as necessary.**

Water damage noted.

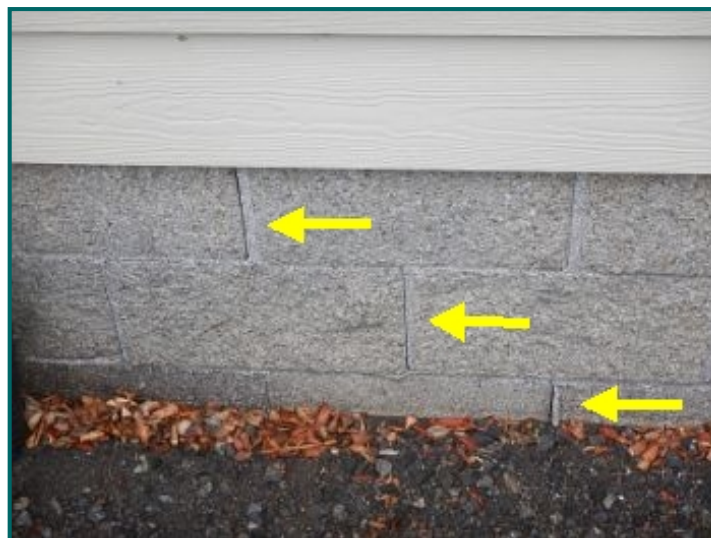
- Cracking noted on the foundation perimeter. Recommended monitoring these cracks. If this condition worsens, recommend having a licensed contractor evaluate and repair as necessary.

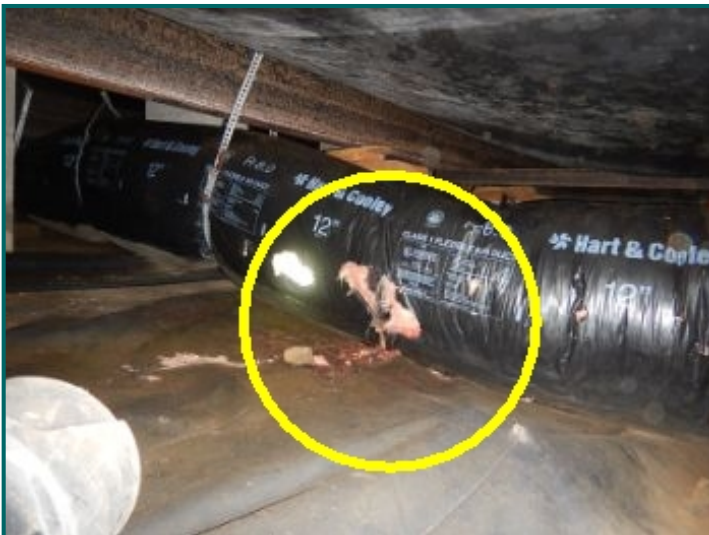
Ducting insulation damaged.

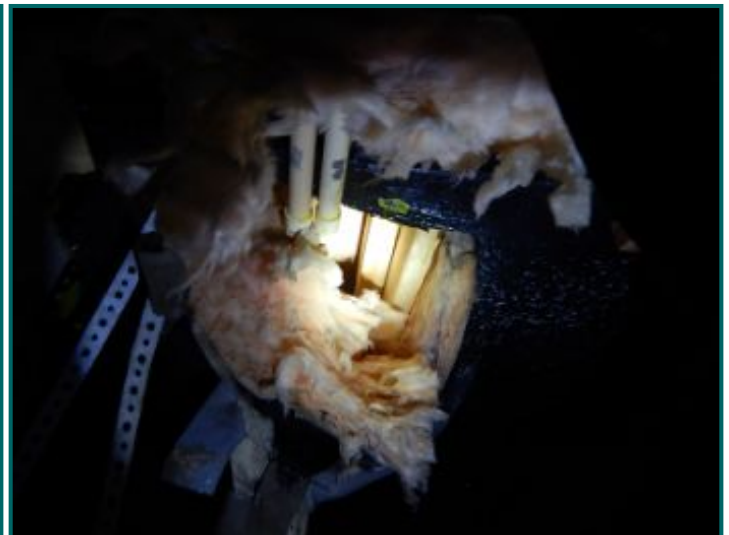
- Rodent nests observed in insulation. Recommend sealing all gaps and cracks to prevent future infestation and consulting with a pest specialist to eliminate any present rodent infestation.

Insulation torn down.
